ALGA 2019 Annual Industry Excellence Awards

Former Fuel Depot Demolition

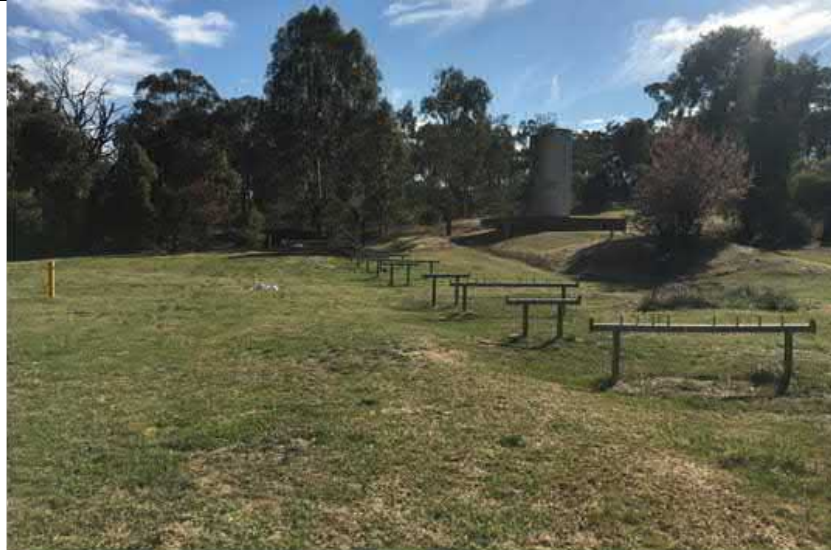
Plate No.
1

Description:
MW18 and 2 X AST
heating oil tanks, T8 and
T9 (looking North).

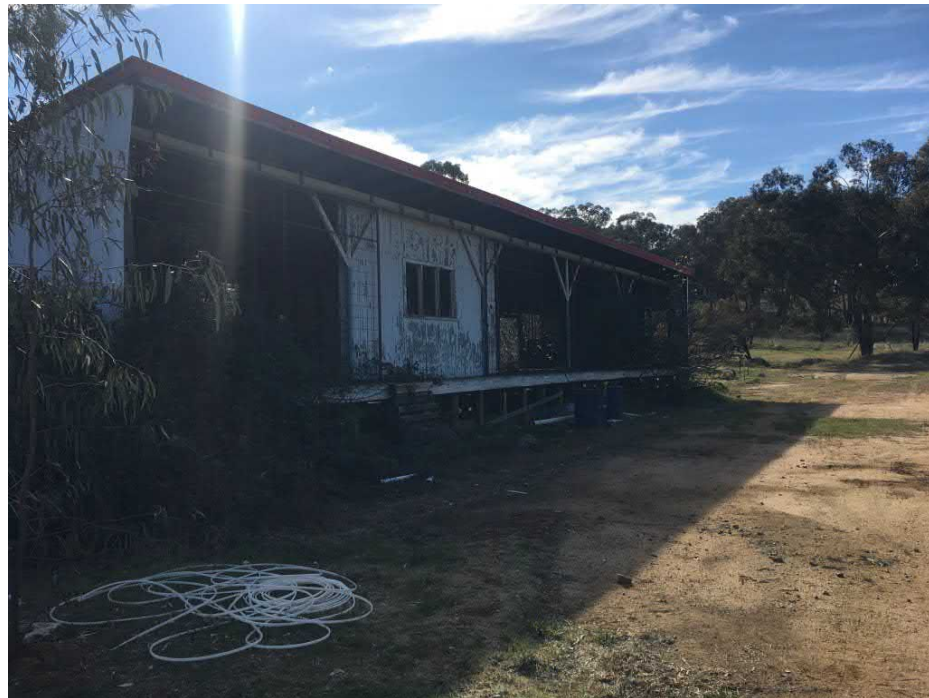
Plate No.
2

Description:
Drum platform workshop
(class 3) / large raised
work shop near site
entrance (looking south
east).

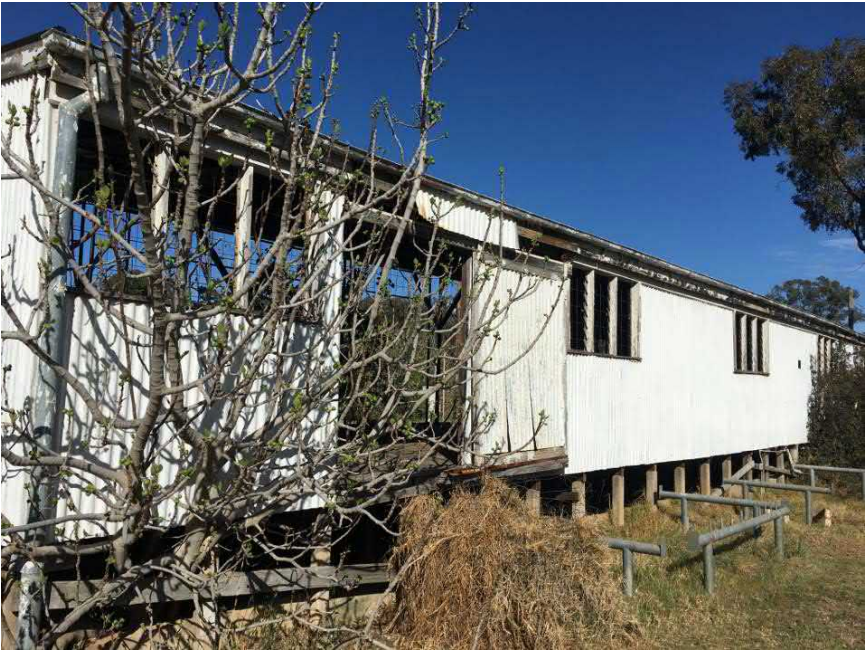
<p>Plate No. 3</p>

<p>Description: Rear view of large raised platform. (looking north west).</p>

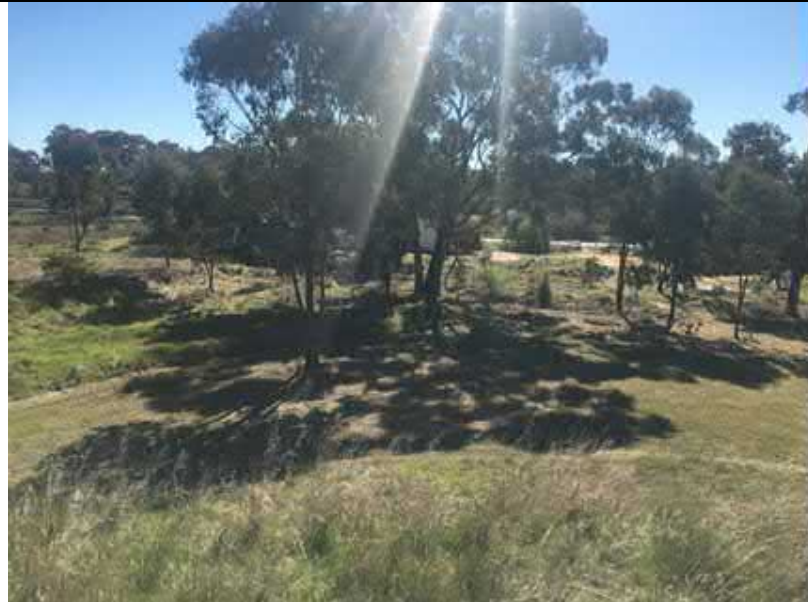
**Plate No.
5**

View of site from top of T5
(looking west).

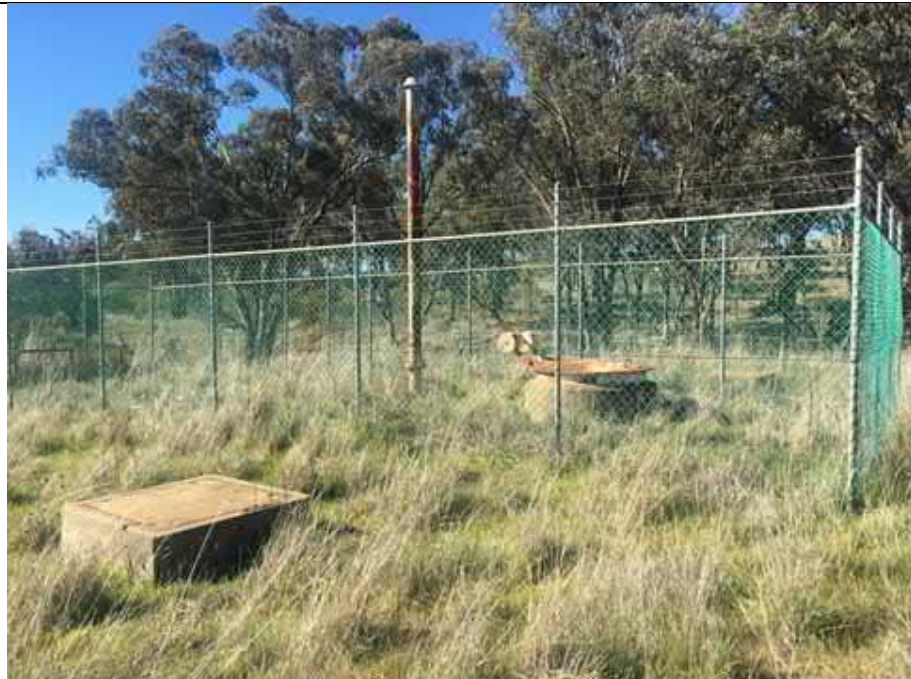
**Plate No.
6**

Top of T5.

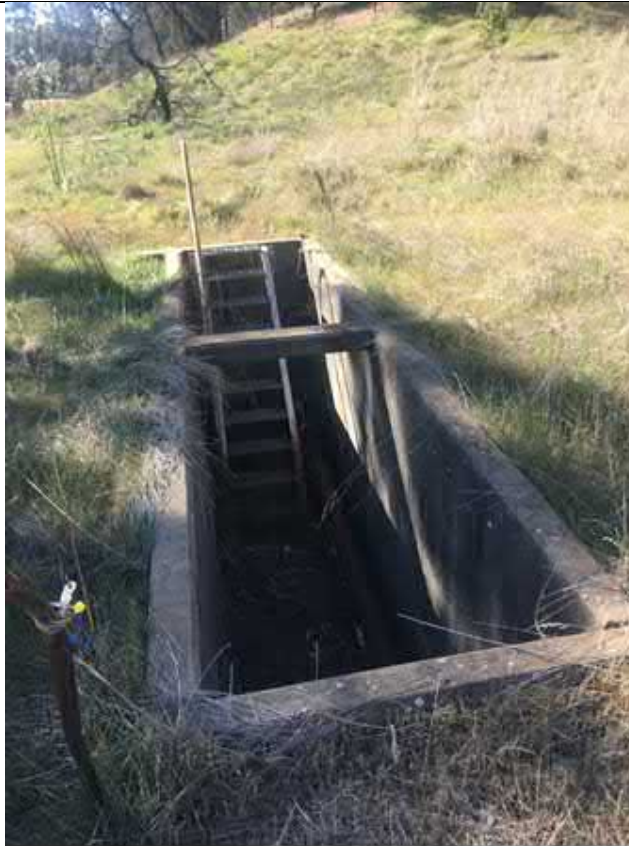
Plate No.
7

Description:
Entrance to buried
AST.

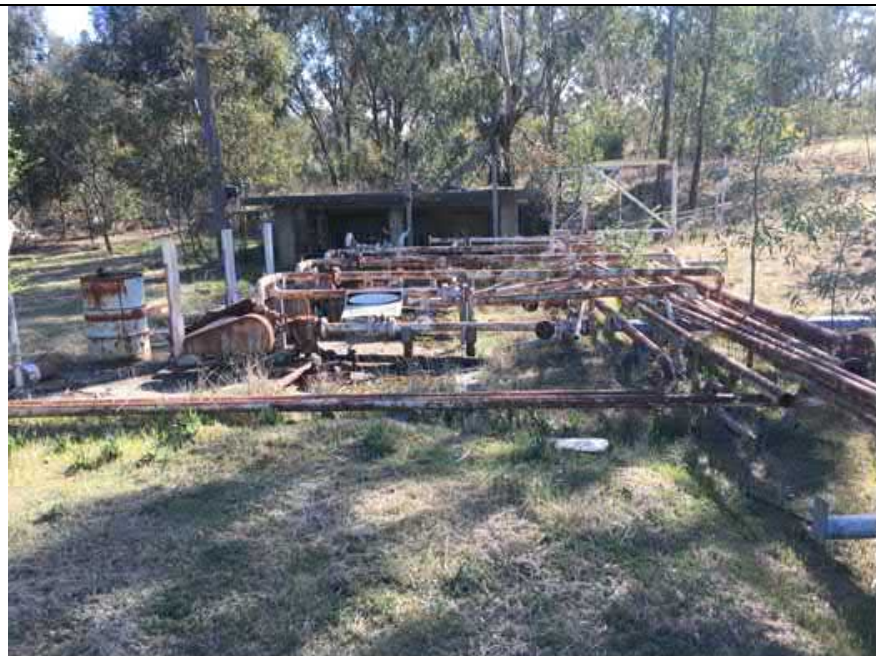
Plate No.
8

Description:
Pipework present near
concrete pumphouse
with asbestos signage
(looking north).

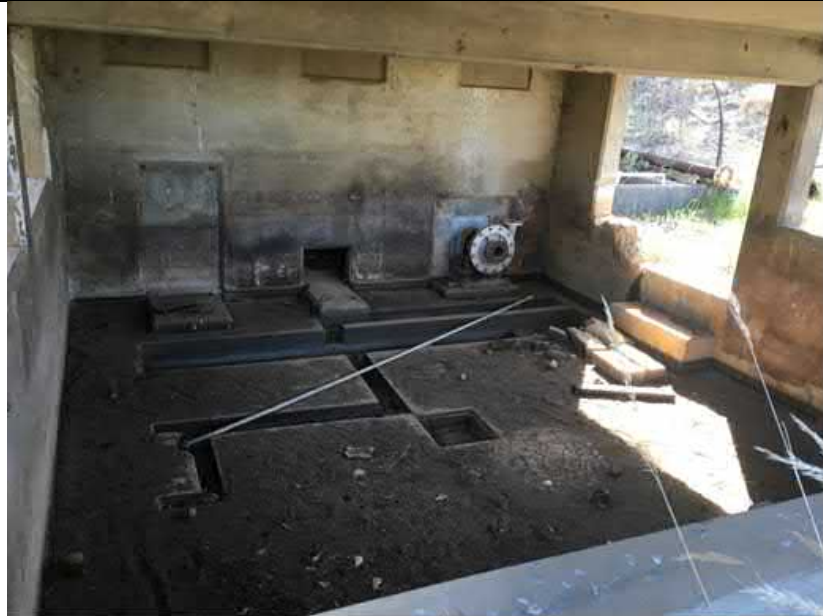
**Plate No.
9**

Description:
Inside concrete
pumphouse.

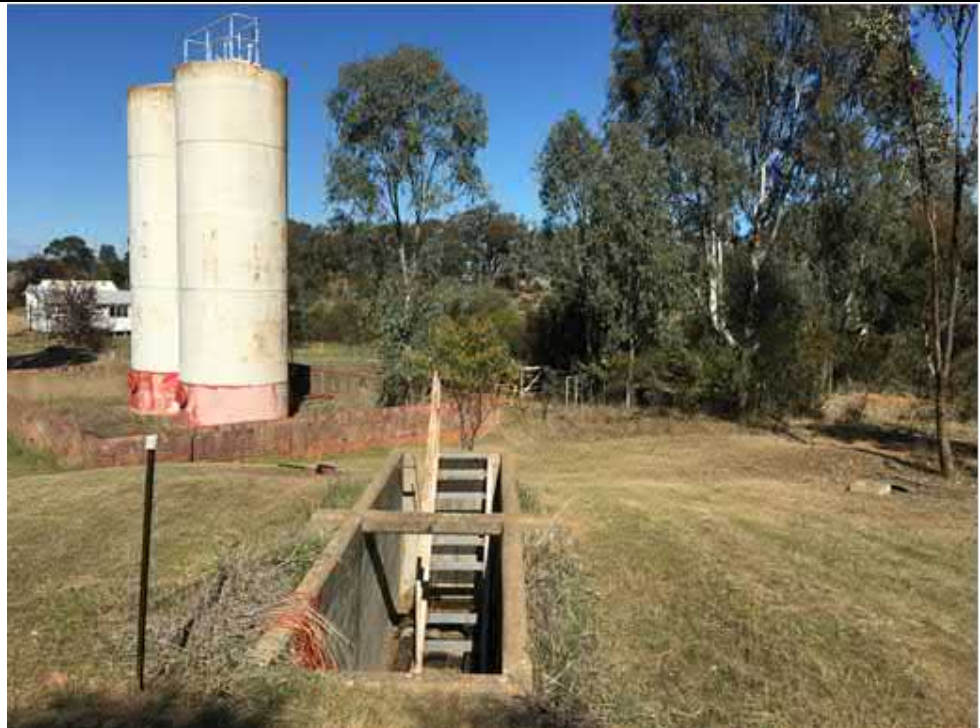
**Plate No.
10**

Description:
T8 and T9 within bunded
area and entrance to T1
looking south west.

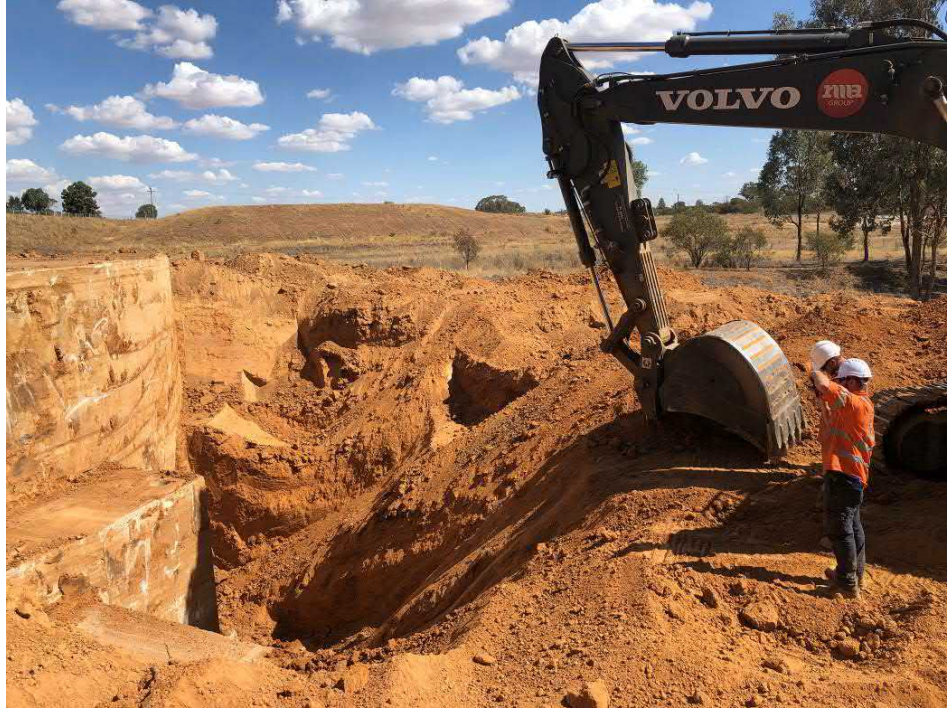
Plate No.
13

- i. Obstacles to the project team was that the site was established in the 1940's and the design structure of the semi buried tanks was not understood prior to uncovering them. This was overcome by carefully uncovering the first semi buried tank to be removed (T3) and once the tank structure was understood a demolition methodology developed. Collaboration between the demolition contractor (RMA Group) and AECOM teams (safety, geotechnical and contamination) to ensure all risks were understood and mitigated. The result was a bespoke solution that minimised the volume of soil required to be moved from around the tanks and eliminated the chance of engulfment of the excavators or operator. Recyclables were separated and stockpiled for offsite disposal. See Photo 11-17 presented in Appendix B.

Description:
Excavating Wall of T3.

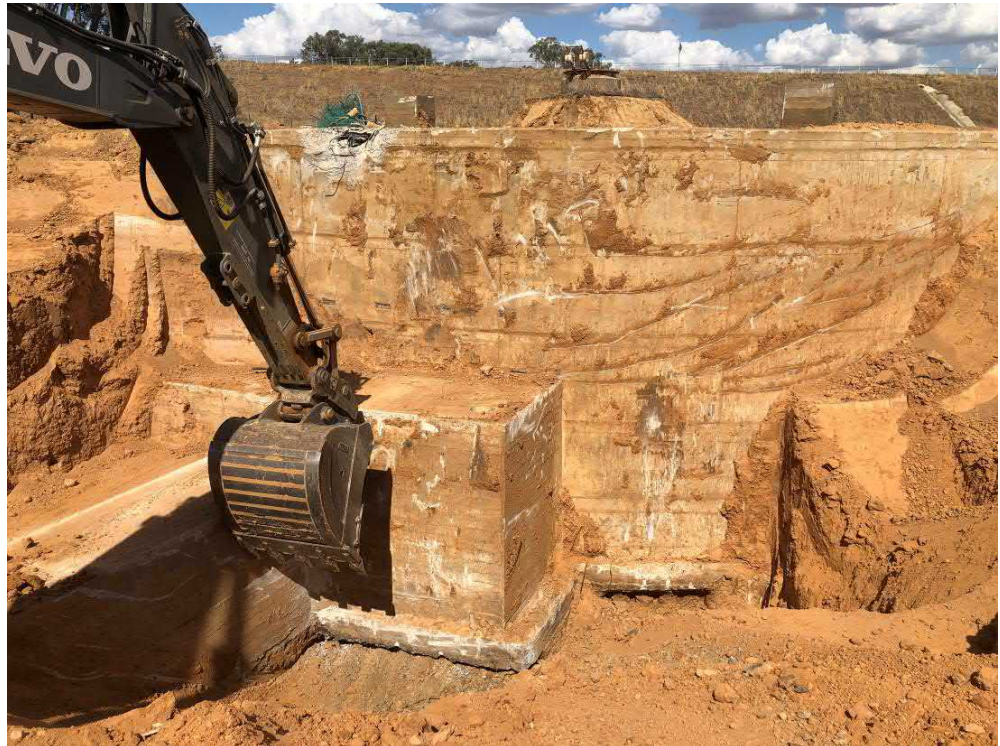
Plate No.
14

Description:
T3 Wall exposed.

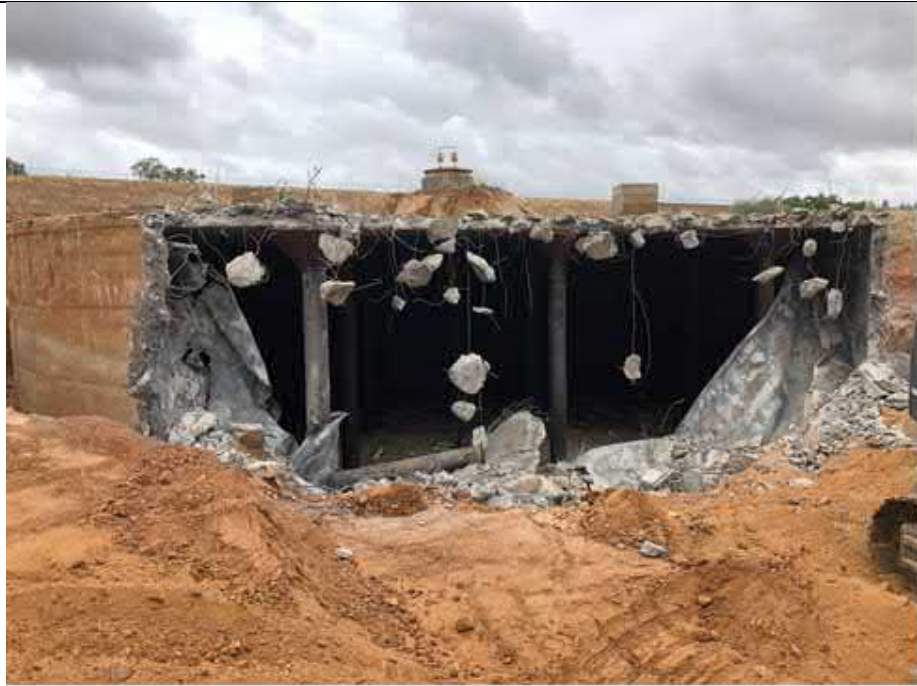
**Plate No.
15**

Description:
Internal structure of T3.

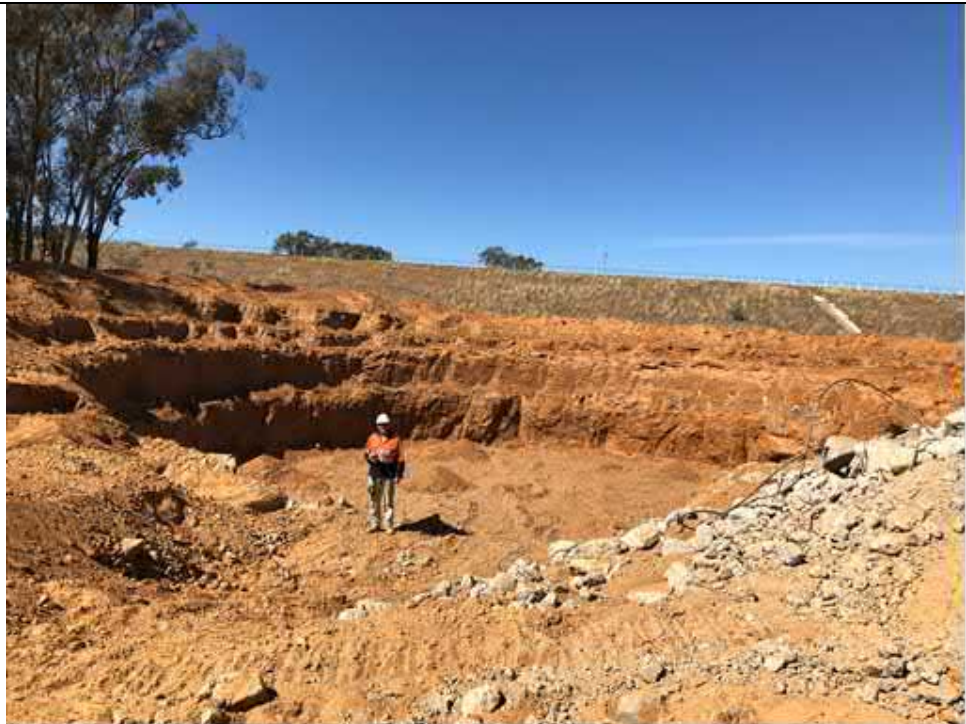
**Plate No.
16**

Description:
T3 fully removed and void left.

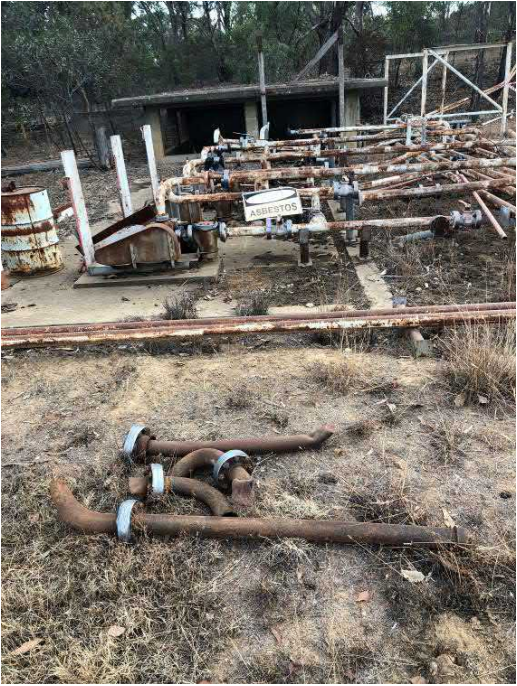
<p>Plate No. 19</p> <p>Description:</p> <p>Removal of asbestos gaskets on fuel lines prior to being double wrapped in PVC plastic for disposal.</p>

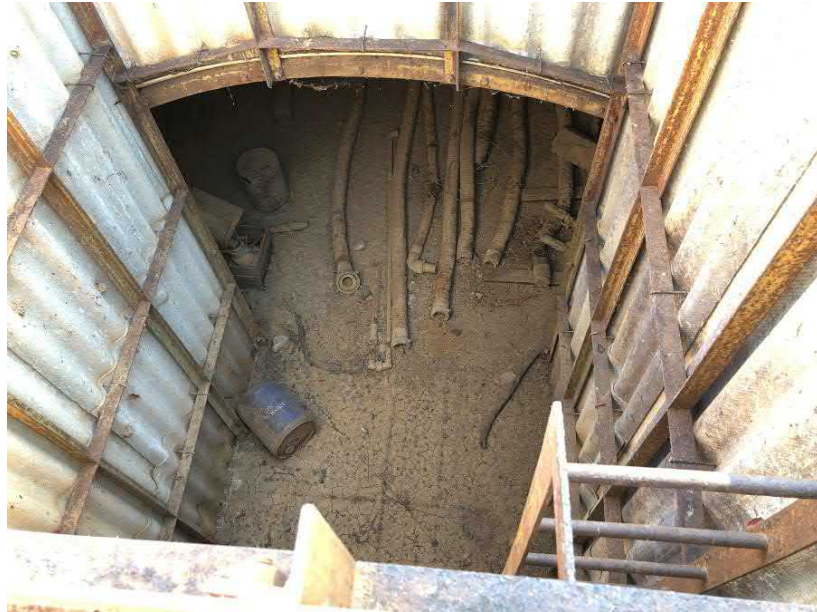
**Plate No.
21**

Description:
Lines observed in bunkers
T12 and T14.

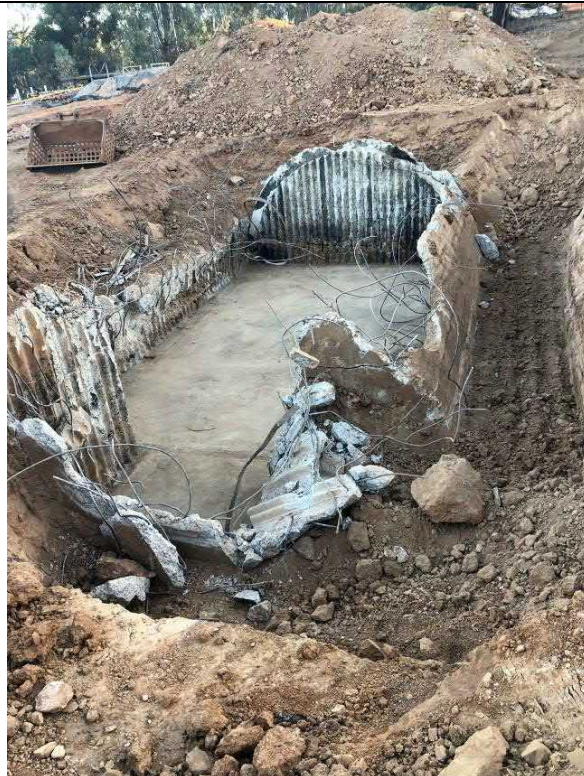
**Plate No.
22**

Description:
T14 during demolition

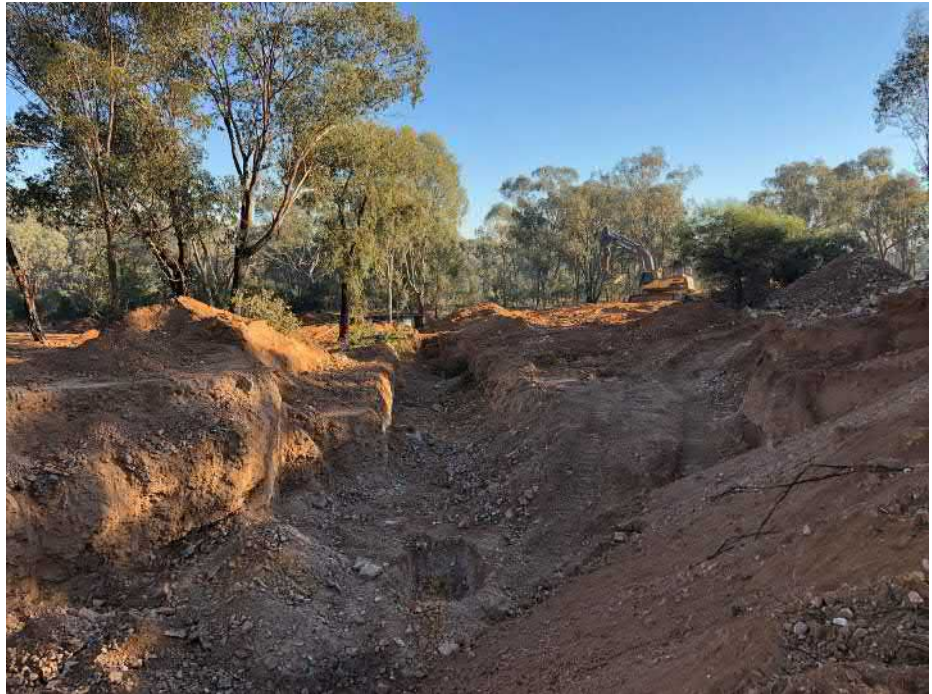
**Plate No.
23**

Description:
Fuel line removal trench.

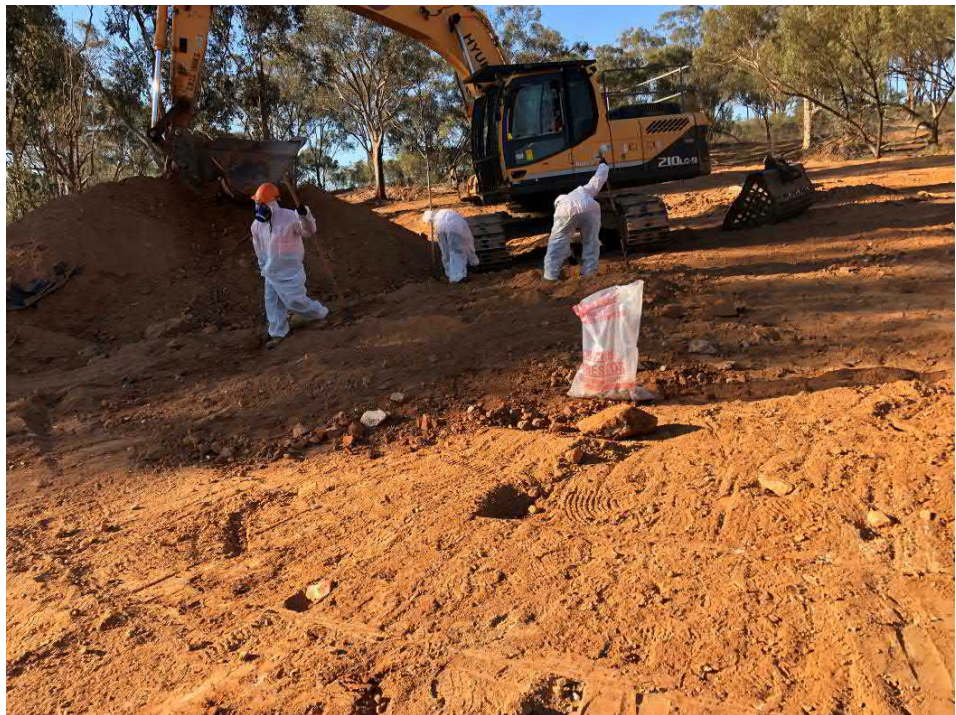
**Plate No.
24**

Description:
Hand picking of asbestos
fragments identified in
soils

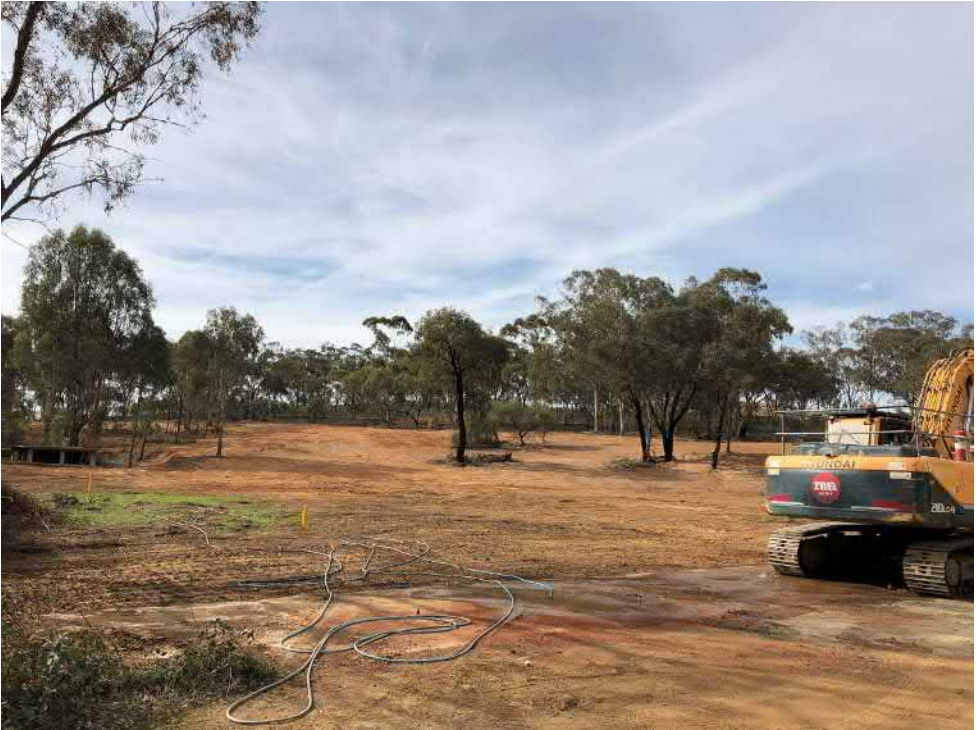
<p>Plate No. 25</p> <p>Description: Site finishing.</p>
