ALGA Annual Industry Excellence Awards
Submission for: Award 2: Best Remedial Project (<\$1M)
Submission by:

Project Overview

The Augusta Power Stations (APS) have a long and valued history providing reliable electricity generation to the South Australian and National Electricity Market since 1954. The APS site is located near the township of Port Augusta, approximately 300 km north of Adelaide. Power generation was secured through the utilisation of coal from the Leigh Creek Coalfields, transported along a dedicated 250km rail line connection. The mining and power generation industries at Port Augusta and Leigh Creek contributed significantly to the region's economy for over 60 years.

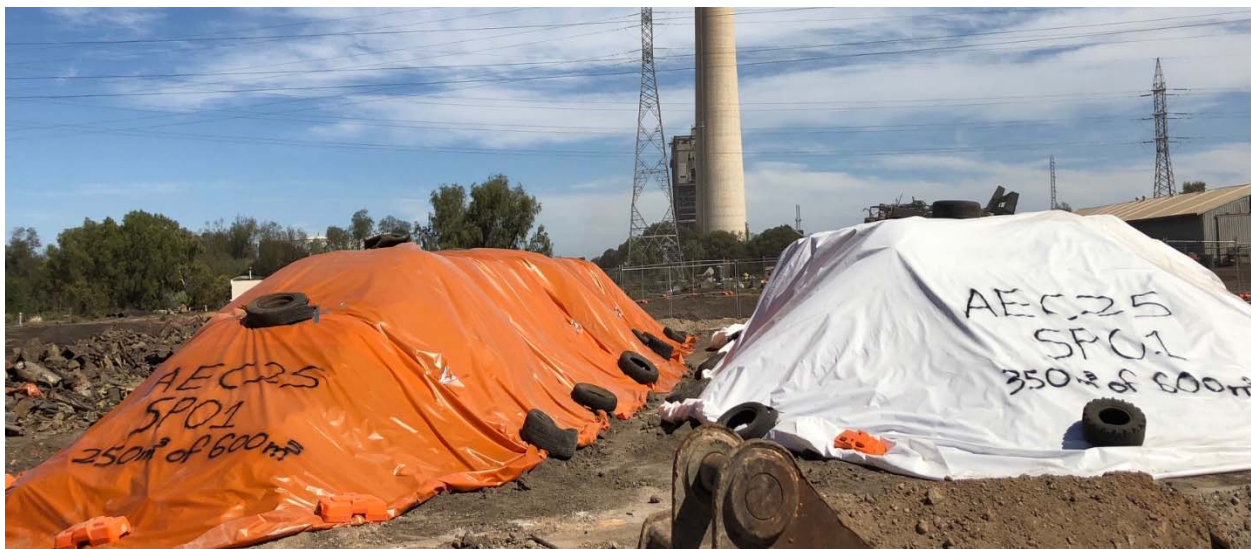
Photo 3 – Covered biopiles at APS

Kleinfelder adopted a staged remediation approach to areas of contaminated soil, including the establishment of bioremediation pads for the stockpiling and bioremediation of excavated contaminated soil, and implementation of reinstatement strategies in accordance with regulatory guidelines. Groundwater assessments were undertaken to establish baseline concentrations. Subsequently, the primary contamination sources were remediated and validated through sampling and analysis. Post-remediation groundwater monitoring was conducted to demonstrate the success of the remediation.

Environmental: Following their closure, hydrocarbon impacted soil and groundwater was identified in eight areas across the two sites. This was deemed to present an environmental risk if not addressed. Kleinfelder bioremediated over 3,000 m³ of impacted soils on-site, using purpose-built treatment pads, bio-augmenting the soils with the application of di-ammonium phosphate and aerating the material through turning over using mobile plant. The soil piles were carefully managed to reduce environmental impacts from dust and sediment runoff. Groundwater in the excavations and the saturated soils were dosed in-situ with a persulfate-based chemical oxidant to enhance groundwater remediation. Validation soil sampling and post remediation groundwater sampling was performed to confirm the success of the remediation. The on-site re-use treated soil was maximised, including the filling of an existing void within a former basement at the APS. The adopted remediation approach enhanced natural processes, reduced energy requirements and meant soils were re-used at site without disposal to off-site landfills.

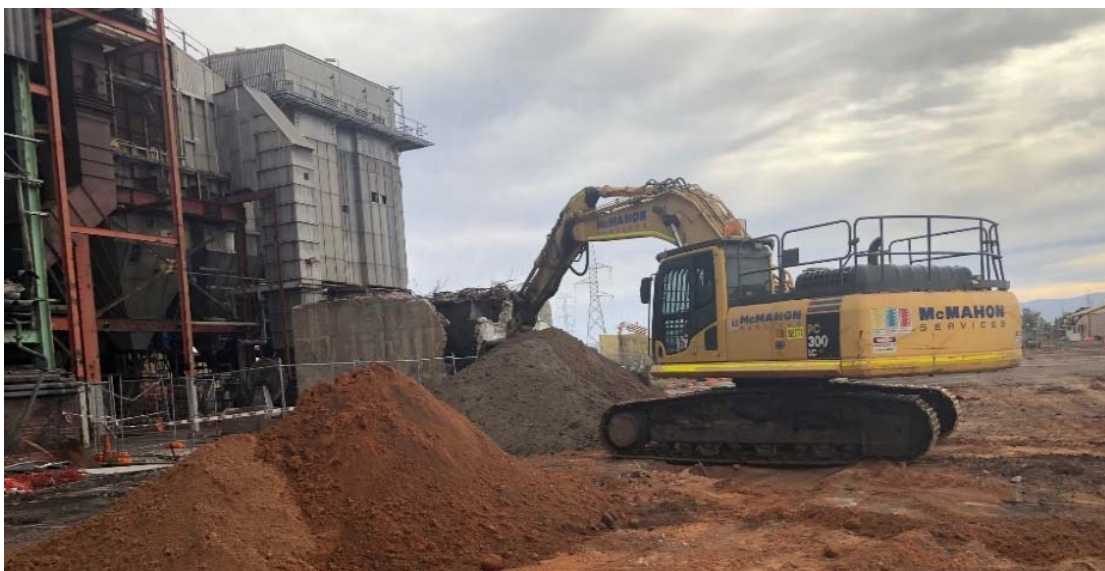
Photo 4 – Soil excavation and movements at APS

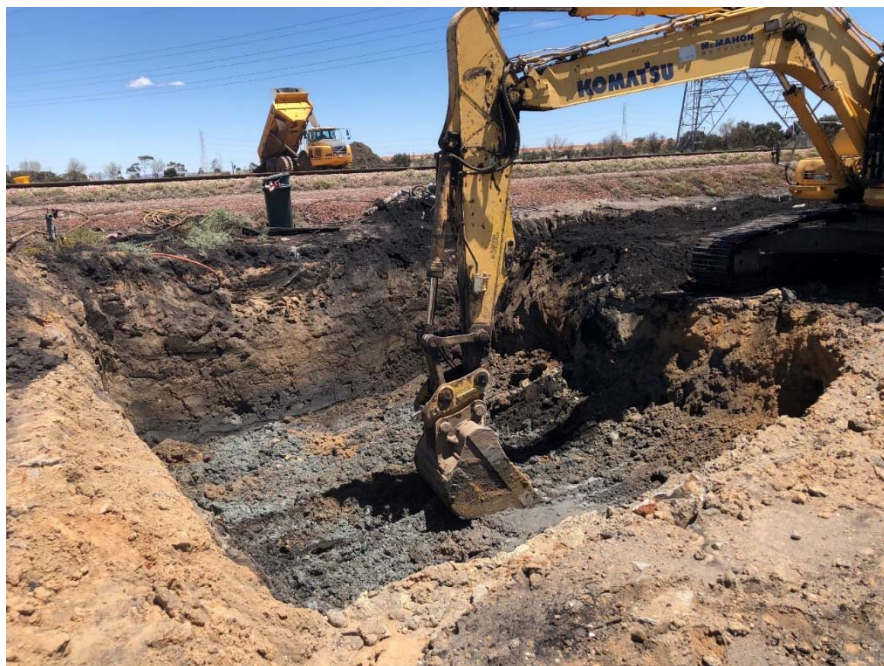
Photo 5 – Soil excavation adjacent to former power station at APS

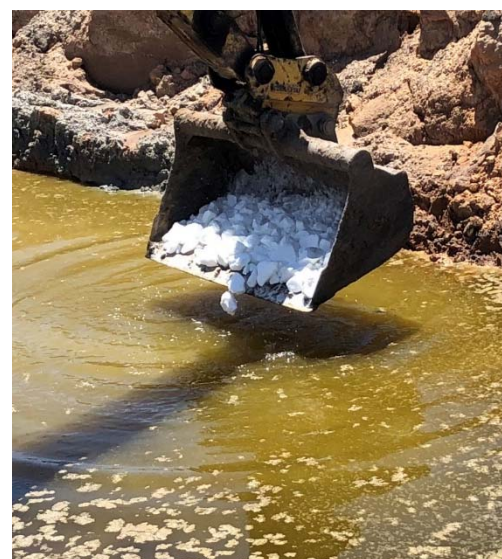
Photo 6: Addition of chemical oxidant to saturated soils within open excavation to enhance biodegradation
